Evaluation Report

Riteway RS-400 Field Sprayer

ALBERTA
FARM
MACHINERY
RESEARCH
CENTRE

PRAIRIE AGRICULTURAL MACHINERY INSTITUTE

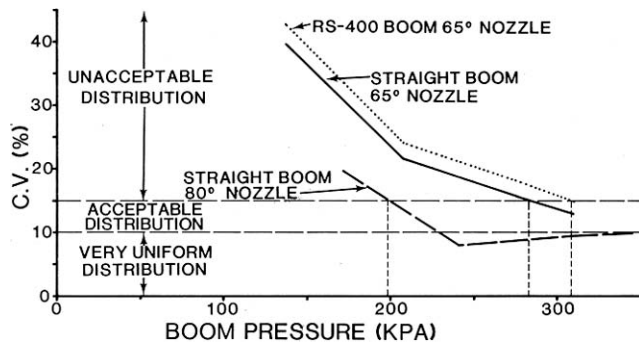
Figure 6. Spray Pattern Uniformity at Various Boom Pressures with 65° and 80° Nozzles.

Figure 6 compares spray pattern uniformity at various boom pressures, for the RS-400 boom with angled centre nozzles (Figure 2), for a straight boom without angled centre nozzles, both using 65° nozzles (TeeJet 6501), and for a straight boom using nozzles of the same capacity but with a spray angle of 80° (TeeJet 8001).

Spray distribution was unacceptable on the centre boom section at pressures below 310 kPa (45 psi). Using the same 65° nozzles on a straight boom section, spray distribution was unacceptable at pressures below 283 kPa (41 psi). Neither of these boom configurations produced very uniform distribution (CV less than 10%) in the accepted operating range below 310 kPa (45 psi). However, the straight boom section with 80° nozzles produced acceptable spray distribution at pressures above 200 kPa (29 psi) and in the range from 225 to 340 kPa (33 to 50 psi) the distribution was very uniform. It is evident that 80° nozzles would greatly improve spray distribution and allow spraying at lower pressures to reduce drift.

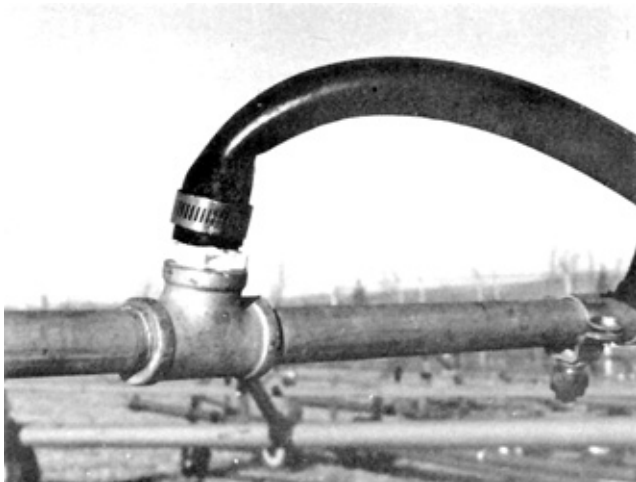
Figure 12. Buckling of Supply Hose at Boom Inlet.

Buckling of the boom supply hoses (Figure 12) could possibly cause appreciable pressure drops as the hoses became fatigued. Modifications are required to eliminate this possibility.

6. Modifying the boom hose inlets to prevent buckling of the boom hose.
7. Providing boom hose tie downs and re-routing the hoses to eliminate hose damage.

- 6&7. The boom is now being fed from the end and the hoses have been rerouted.
8. We have not developed a high capacity strainer at the tank filler opening but plan to do so in the future.

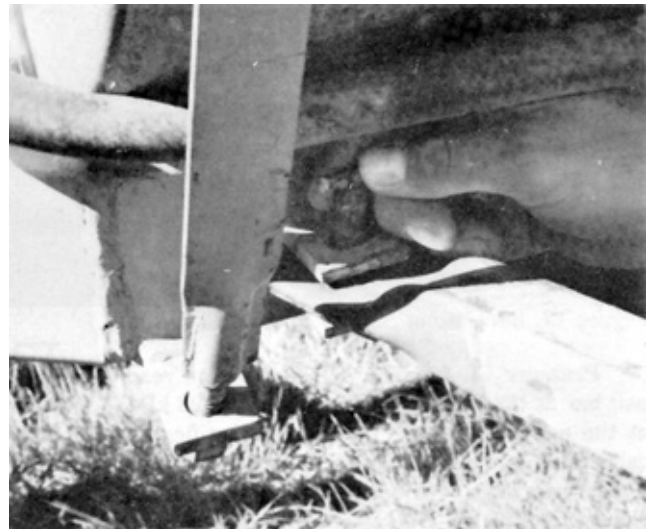
Transport: The RS-400 could be folded into transport by one man in 10 minutes without using tools. The pin located at the front of the radius brace (Figure 16) was difficult to install. Aligning the pin holes was difficult since the bracket was located underneath the tank. Lengthening the bracket to locate the pin further from the

tank would make it easier to place the sprayer in field position.

Figure 16. Awkward Location of Radius Brace Pin.

10. Providing a tank drain plug.
11. Relocating the agitator control valve so that it can be adjusted from the tractor seat.
12. Modifying the front radius arm brackets so they are more accessible.

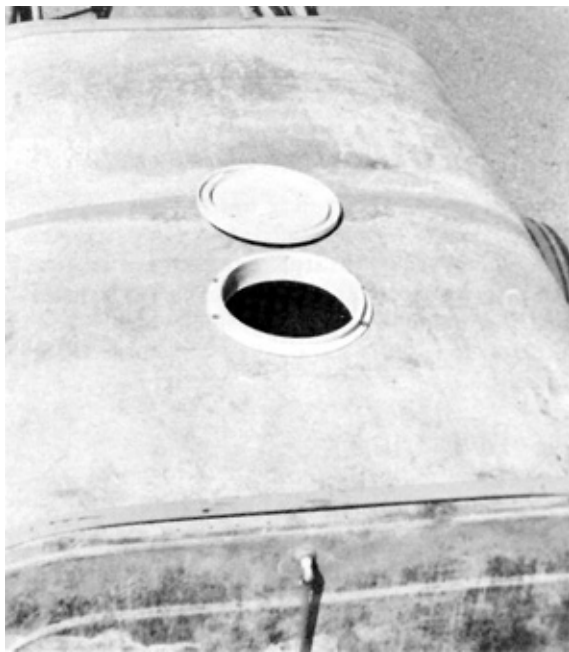
Tank Filling: The low profile tank was easily filled by gravity from a nurse tank on a farm truck. The 255 mm (10 in) filler opening was adequate for adding chemicals and water. Tank filling would have been more convenient if the opening was located closer to one edge of the sprayer tank instead of near the centre (Figure 18). There was also no convenient place to stand while lifting and pouring chemicals into the tank. An operator stand or platform should be provided to prevent the possibility of spillage or slipping while handling toxic chemicals.

Figure 18. Location of Tank Filler Opening.

8. Supplying a high capacity 100 mesh strainer at the tank filler opening.
9. Relocating the tank filler opening and providing a platform to facilitate safe and convenient addition of chemicals to the tank.

9. We are considering changing the tank filler opening.
10. A tank drain plug will be provided for 1978 production.
11. The agitator control valve has been moved up to the selector valve.
